**TRANSPORTATION SCIENCES CENTER
ACCIDENT RESEARCH GROUP**

**CALSPAN ON-SITE AIR BAG DEPLOYMENT INVESTIGATION
CALSPAN CASE NO. 95-2
VEHICLE: 1994 FORD F-150 PICKUP TRUCK
LOCATION: [REDACTED] MS
CRASH DATE: [REDACTED] 1994**

SUMMARY

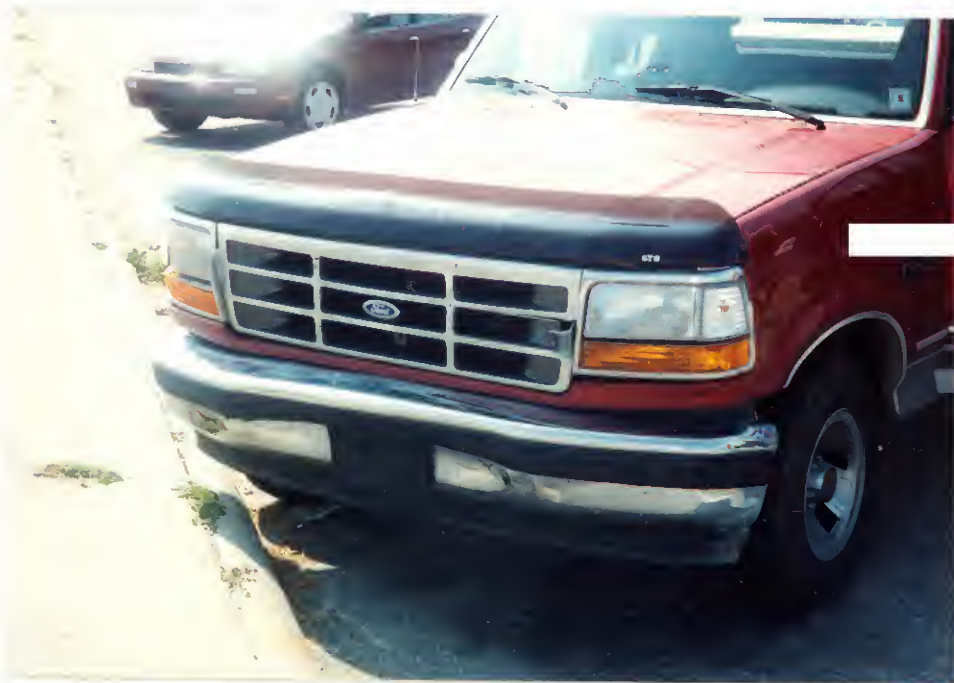
2. Frontal damage to the Ford F-150 pickup truck.

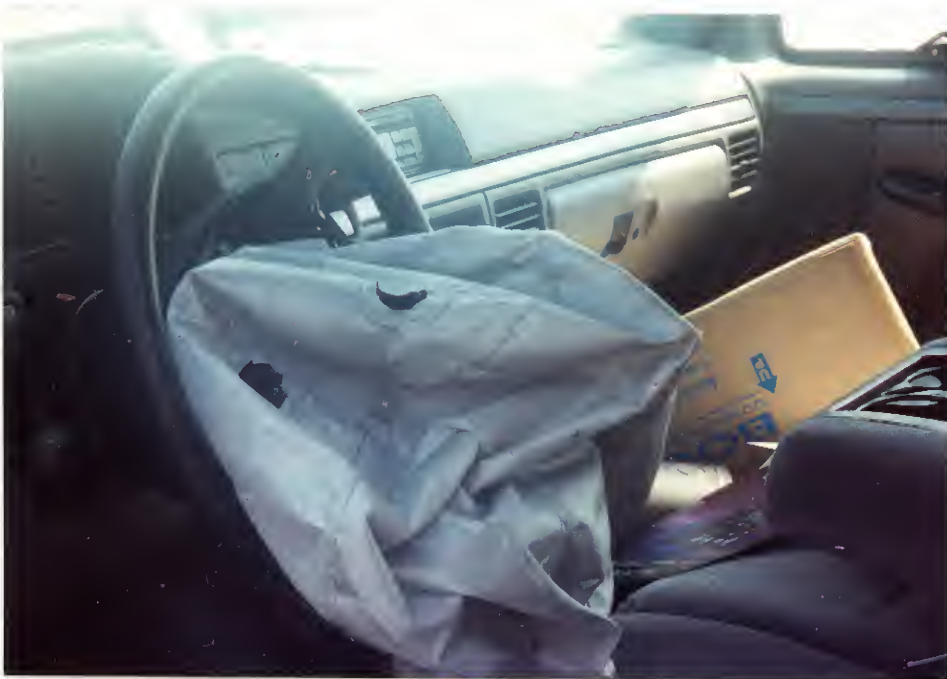
4. Close-up view of the deployed air bag and the separated upper module cover flap.

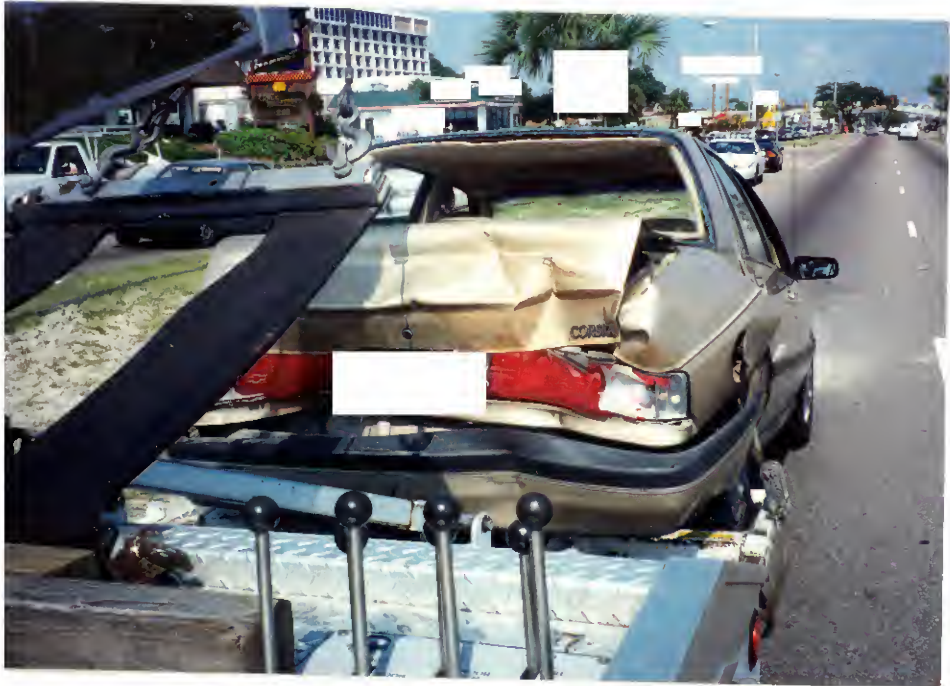
5. Rear damage to the Chevrolet Corsica.

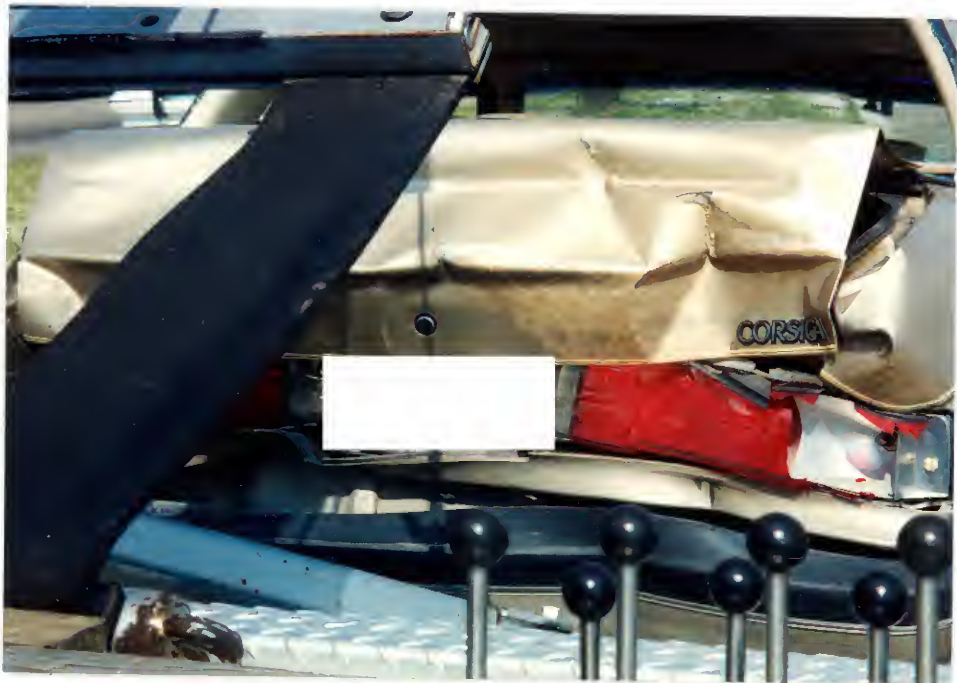
6. Close-up view of the rear damage to the Corsica.

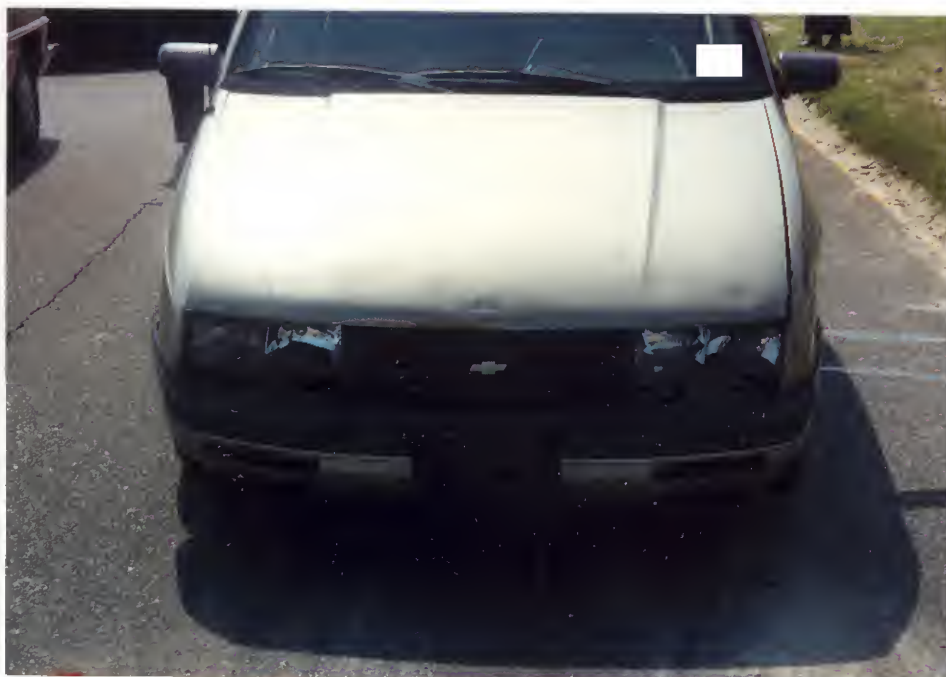
8. Frontal damage to the Corsica from secondary contact with the Nissan 240 SX.

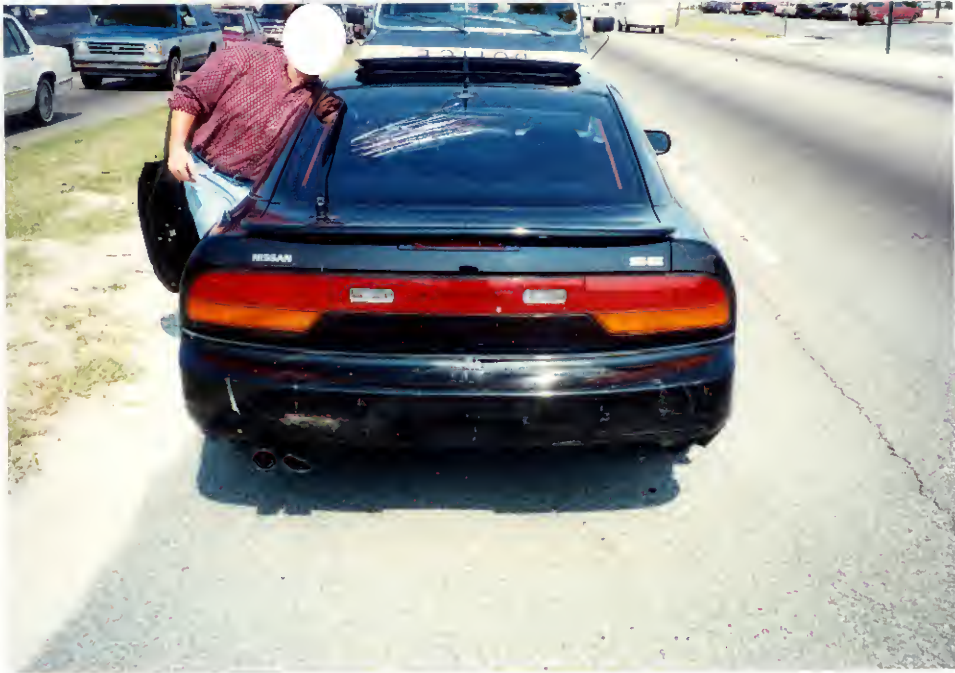
The rear of the Nissan 240 SX minor damage from its impact sequence with the Chevrolet Corsica. Direct contact damage was distributed across the rear bumper fascia of the Nissan. There was no damage to the taillamp lenses or hatchback of the vehicle.

9. Rear damage to the bumper fascia of the Nissan 240 SX.

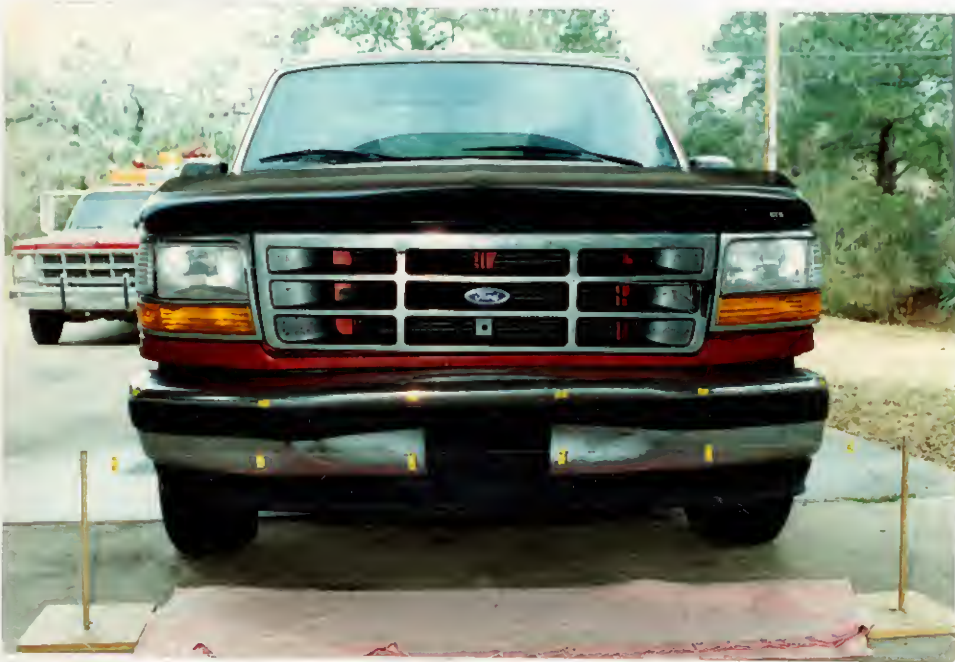
Exterior: The 1994 Ford F-150 pickup sustained minor frontal damage from its impact sequence with the rear of vehicle #2. Maximum crush was 9.1 cm (3.6") located at the mid point of the front bumper face below the rub strip, behind the plastic license plate frame. The direct contact damage width was 139.7 cm (55.0") which extended across the bumper and grille from headlamp-to-headlamp. The direct contact damage consisted of abrasions on the bumper rub strip and cracks across the full width of the plastic grille. The combined induced and direct contact damage width was 182.2 cm (71.8") which extended

3. Frontal damage to the involved 1994 Ford F-150 pickup truck.

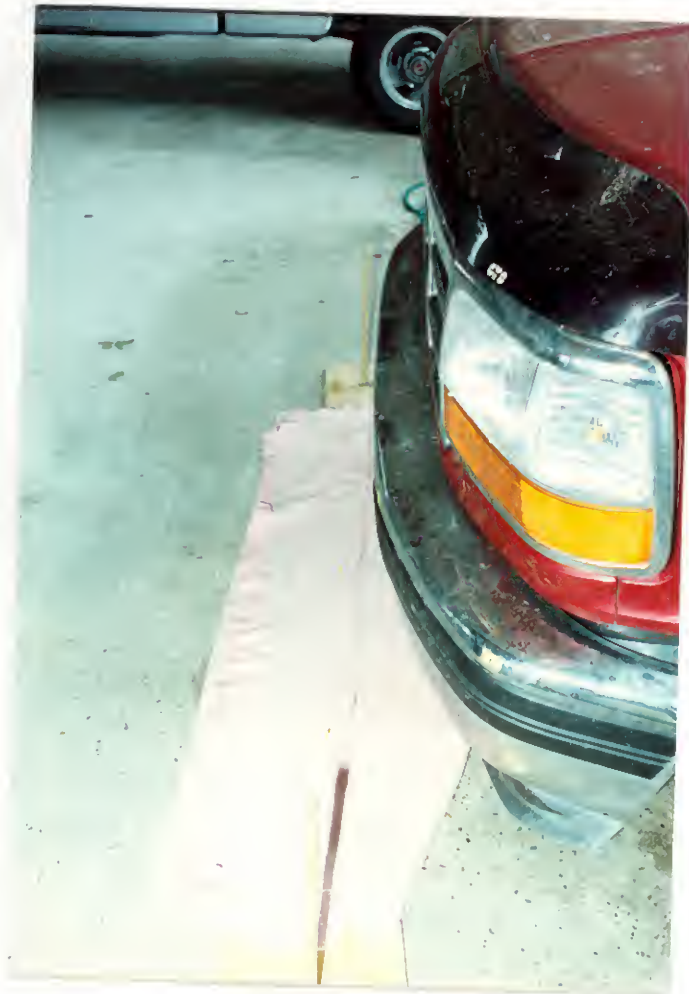
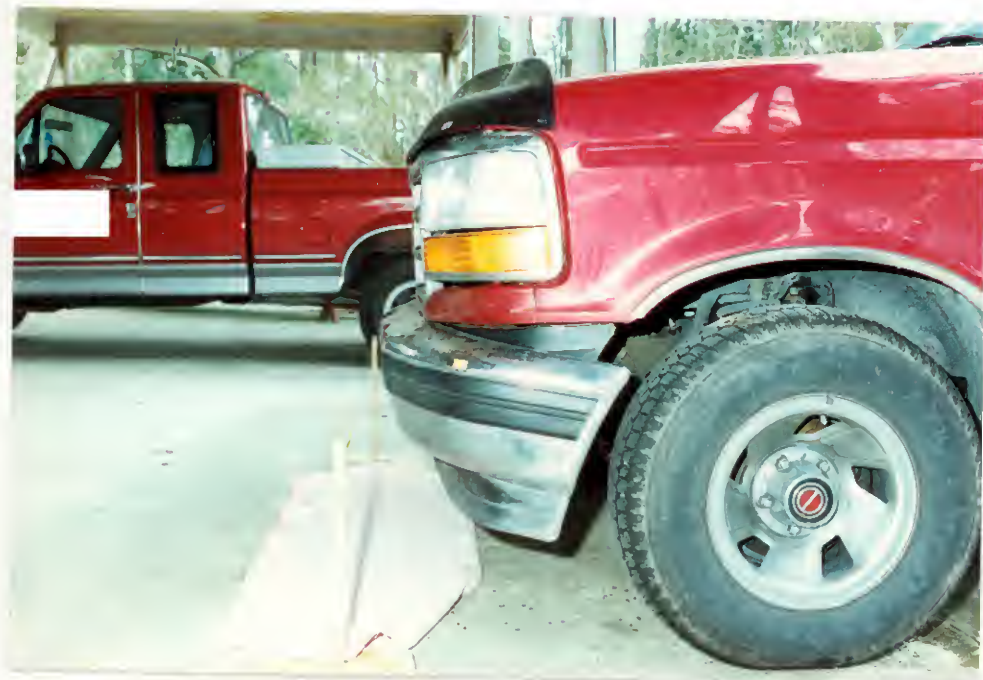
5. & 6. Profile views at the left front corner documenting the extent of crush.

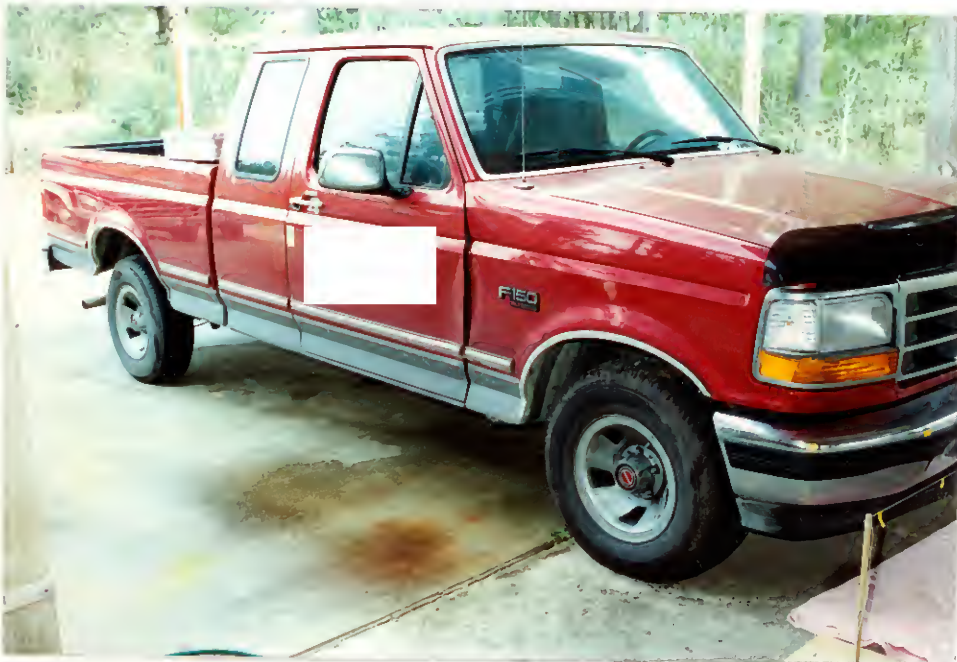
Damaged components consisted of the front bumper, bumper rub strip, grille, right headlamp bezel, and the right front fender and door. The right front fender was displaced rearward by the impact forces. During the extrication of the driver, rescue personnel opened the right door and the leading edge of the door contacted and deformed the trailing edge of the fender. In addition, the leading edge of the right door was damaged.

10. Right side view and displacement of the right front fender.

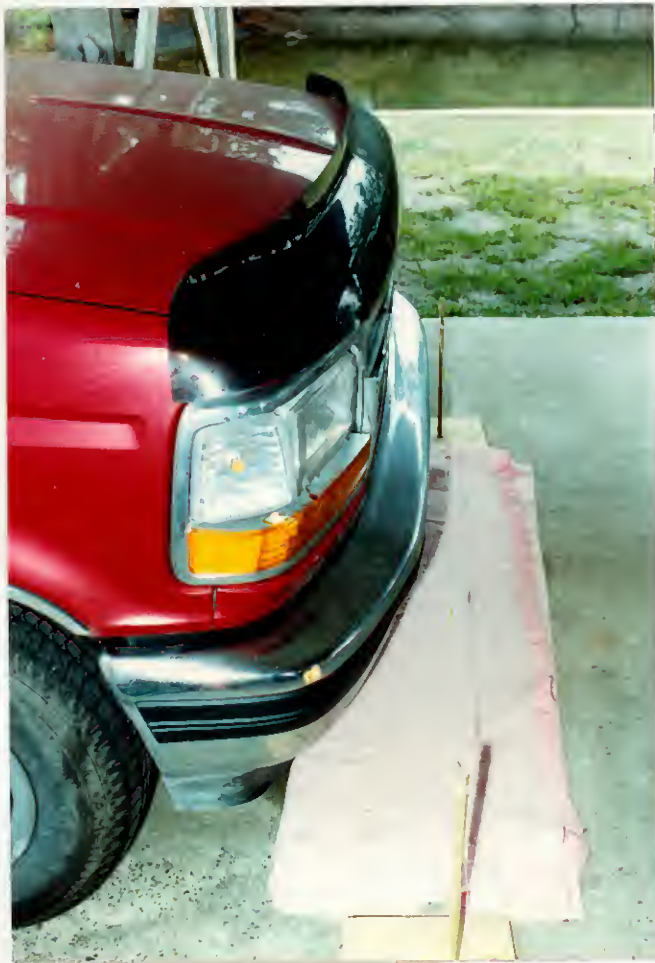
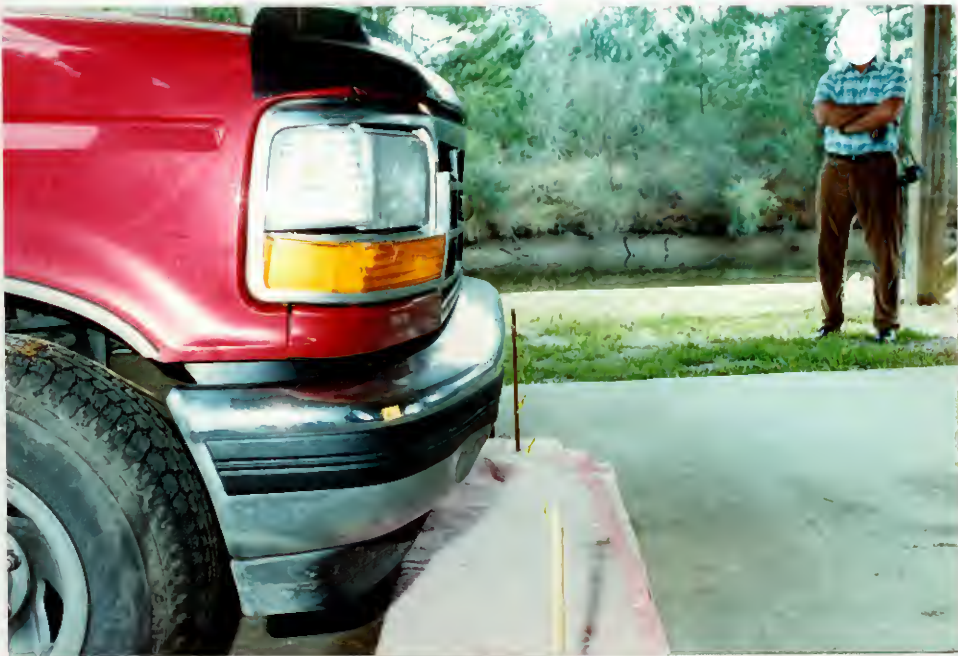
11. & 12. Profile views at the right front corner documenting the extent of crush.

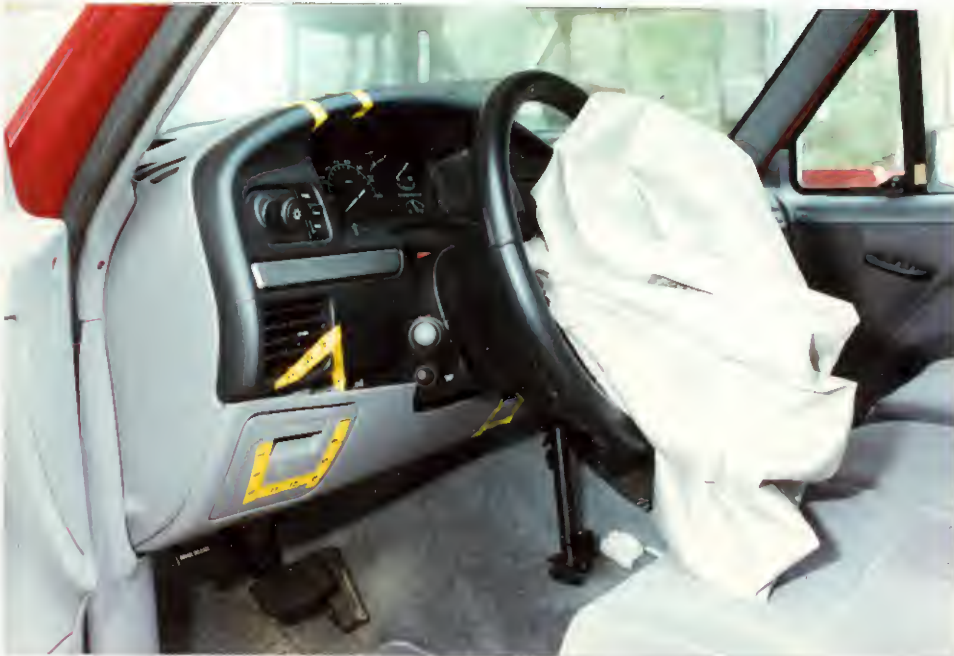
The driver's left knee contacted the mid instrument panel at the base of the vent louver and the fuse box cover that was incorporated into the knee bolster. The knee contact scuffed the components 64.1-71.1 cm (25.25-28.0") left of the vehicle's centerline and 17.1-20.3 cm (6.75-8.0") below the chrome trim which separated the mid and upper instrument panels. His right knee scuffed the knee bolster 25.4-30.5 cm (10.0-12.0") left of the centerline and 20.3-22.9 cm (8.0-9.0") below the referenced trim strip. There was no internal damage to the bolster as documented in Photograph No. 21 of Attachment B.

16. Driver's knee contacts to the bolster and mid instrument panel.

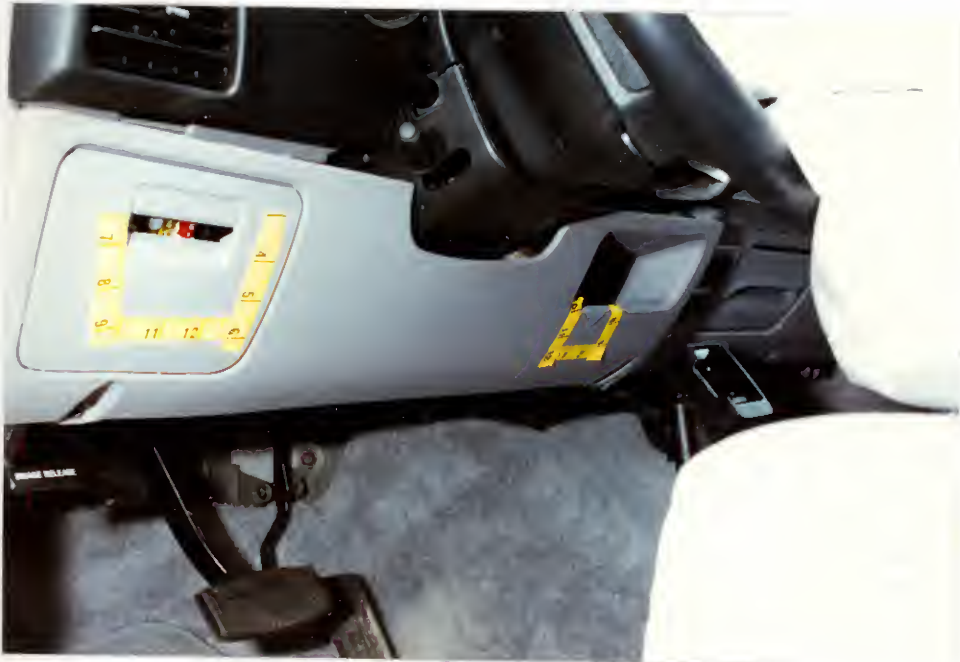
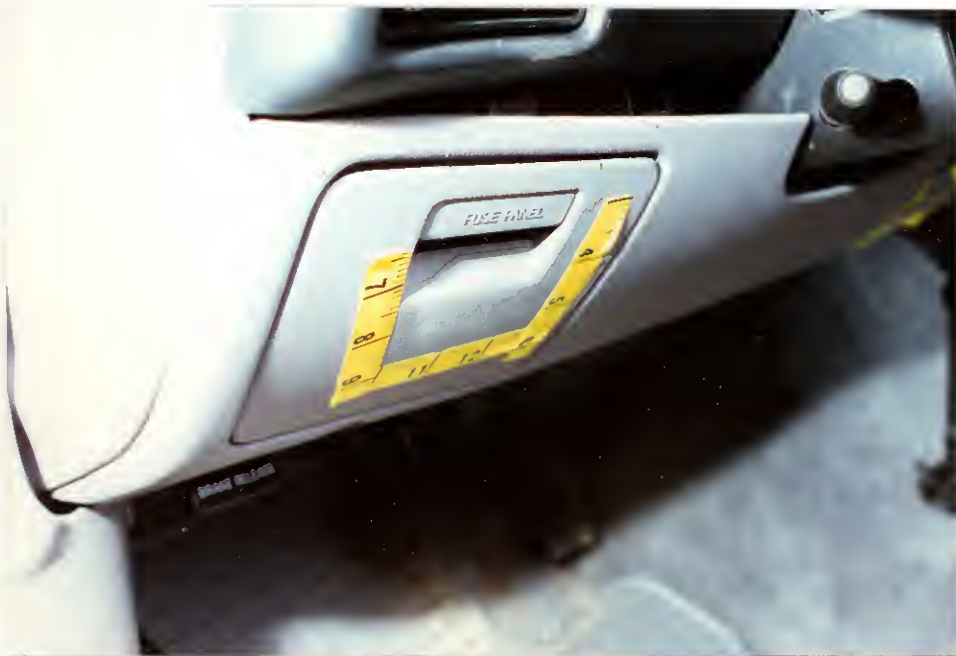
17. & 18. Close-up views of the left knee contact.

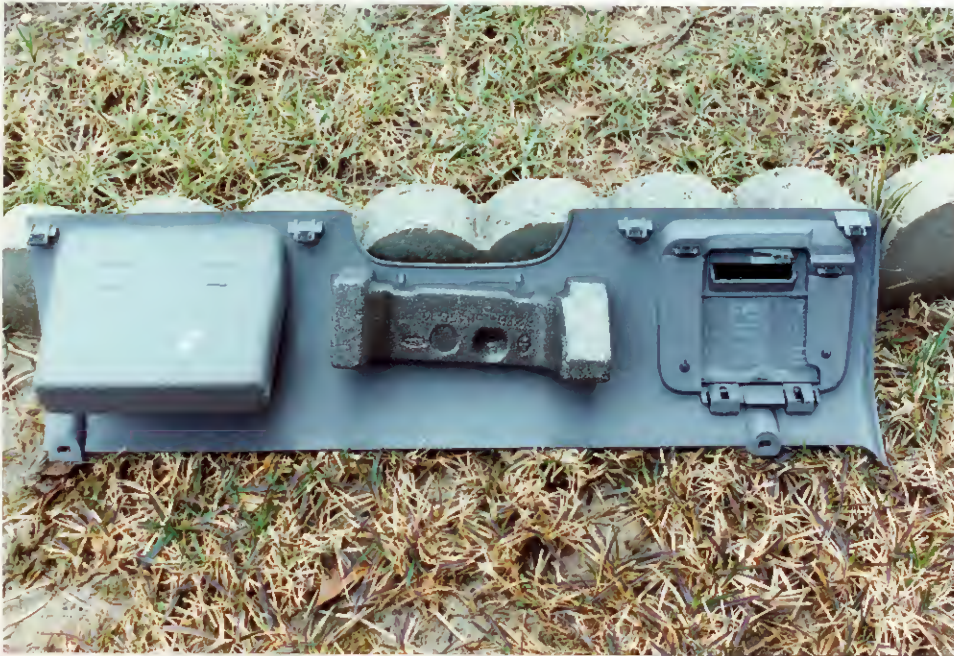
21. Back side of bolster, no damage.

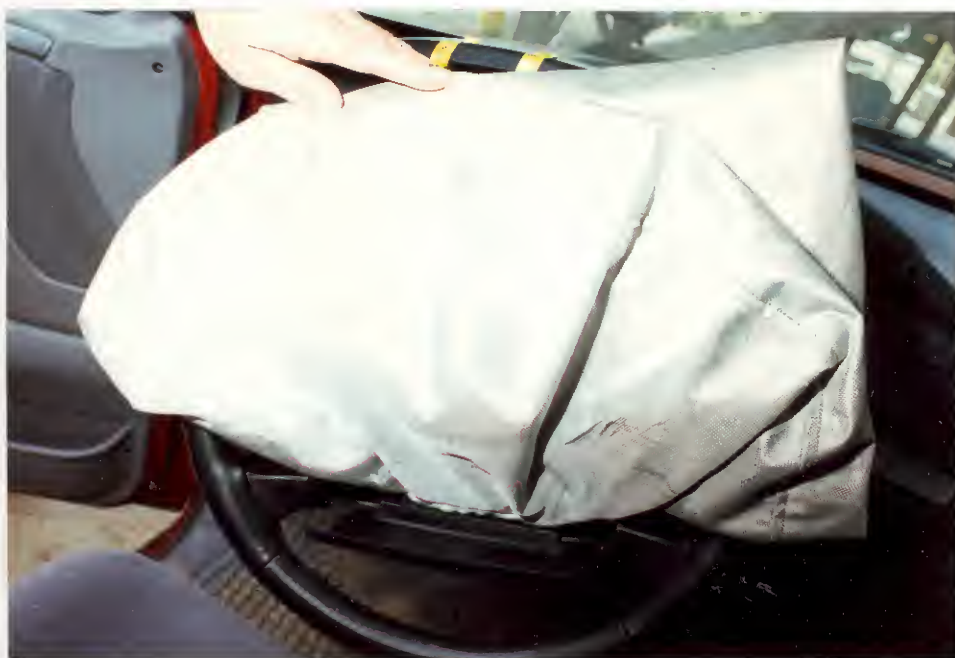
23. Black vinyl transfers at the 6 o'clock sector from the lower module cover flap.

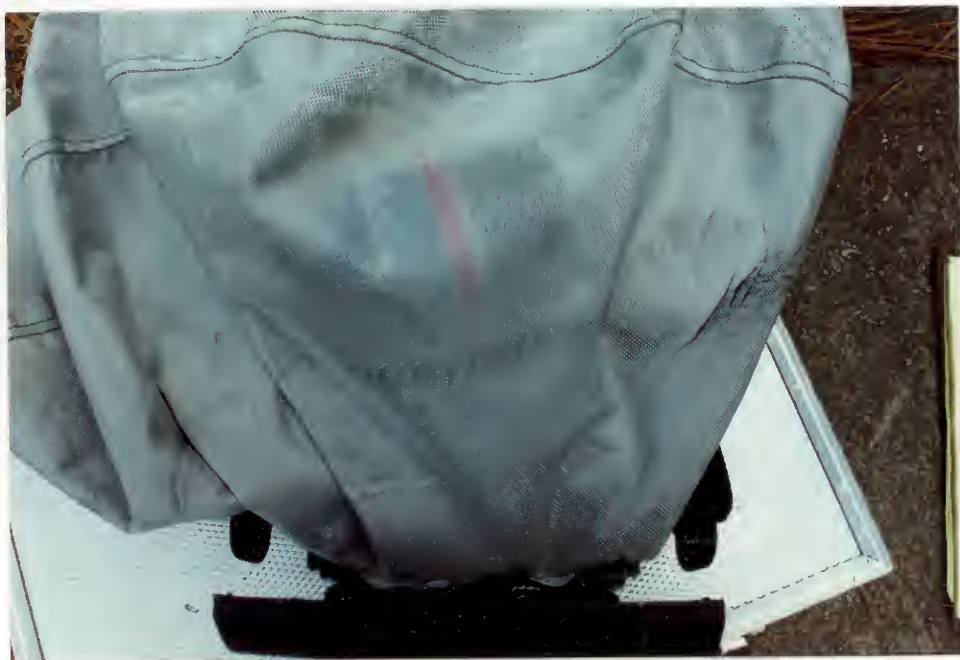
transferred on the air bag at the 6 o'clock sector (refer to Photograph No. 24). In addition to the shirt damage, the driver had a leather bound pocket calendar in one of the shirt pockets. The side of the leather calendar that was exposed to the air bag had a white transfer from the air bag fabric that was both patterned and irregular (refer to Photograph Nos. 54 and 55 of Attachment B). Fabric fibers from the driver's plaid shirt were embedded into the leather calendar in the area of the air bag transfer. The driver's T-shirt was also torn in an irregular pattern over the left chest area.

24. Driver's shirt fabric transfers on the air bag at the 6 o'clock sector.

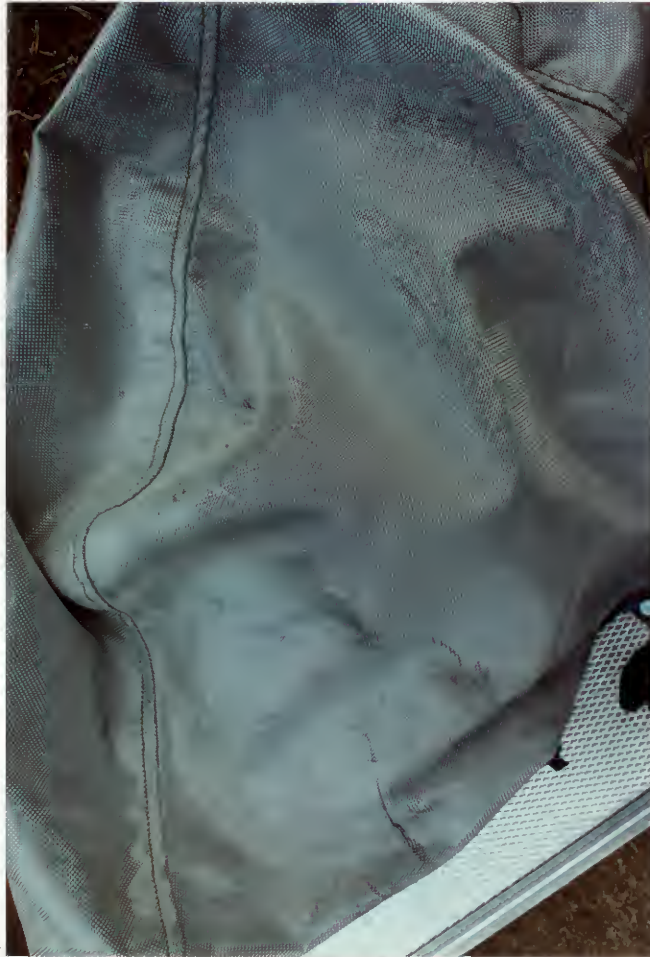
A black vinyl transfer was noted to the right side surface of the bag and was located forward of the peripheral seam. The transfer began 10.2 cm (4.0") below the right vent port and extended approximately 30.4 cm (12.0") downward and 6.4-15.2 cm (2.5-6.0") forward of the seam toward the generator. There were color transfers from the driver's plaid shirt on the air bag at the 3 and 6 o'clock sectors. A large purplish transfer was located on the right side of the air bag which began 22.2 cm (8.75") below the right vent port and extended downward approximately 22.9 cm (8.75"). The upper edge of the transfer was 4.4-12.1 cm (1.75-4.75") forward of the peripheral seam while the lower edge began at the seam and extended 10.2 cm (4.0") forward. In addition, there was a patterned blue, red, and black shirt fabric transfer on the air bag at the 6 o'clock position. The vertically orientated transfer (refer to Photograph No. 24) was located 4.4 cm (1.75") forward of the peripheral seam and was 7.0 cm (2.75") in height and 9.5 cm (3.75") in width.

25. Fabric transfers on the right side of the air bag forward of the peripheral seam.

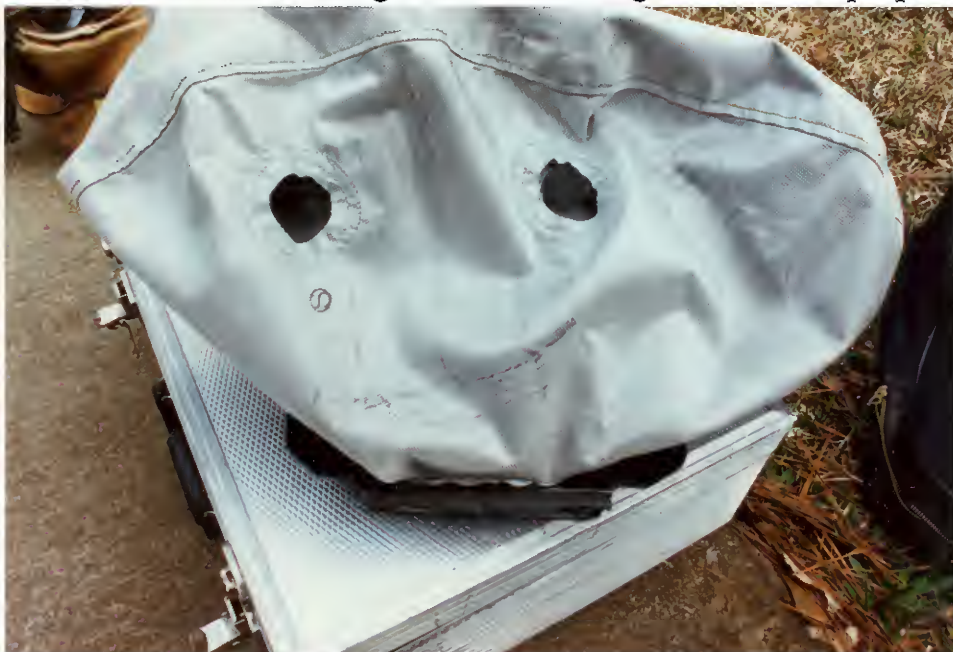
26. Black vinyl transfers at the 12 o'clock sector from the upper module cover flap.

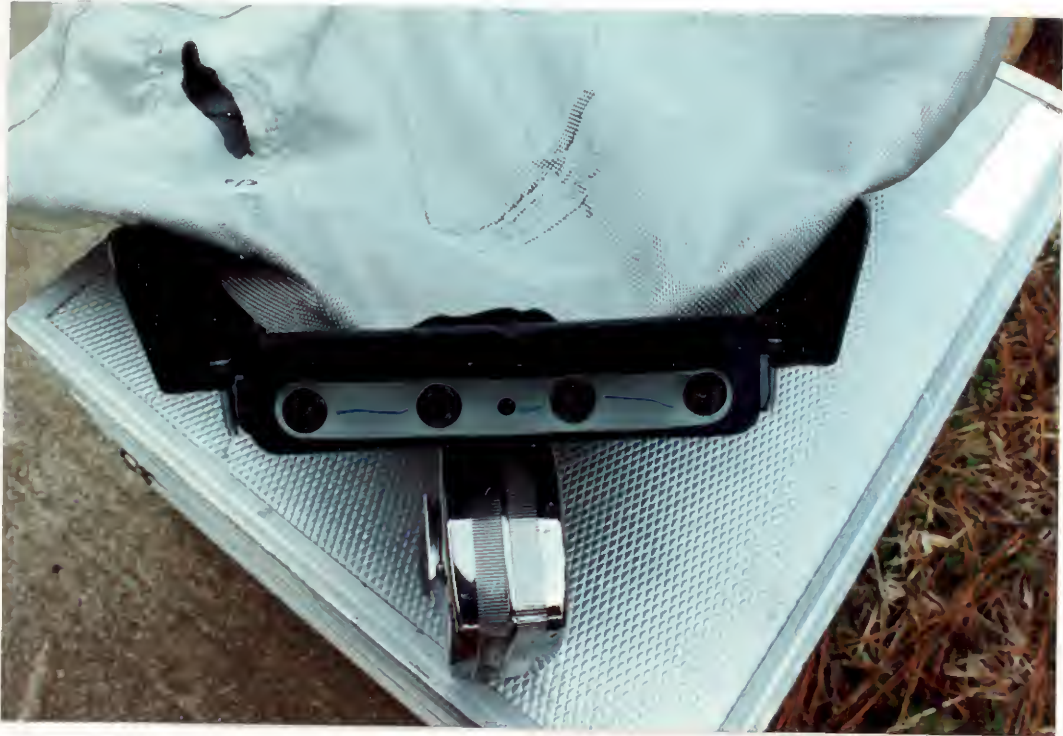
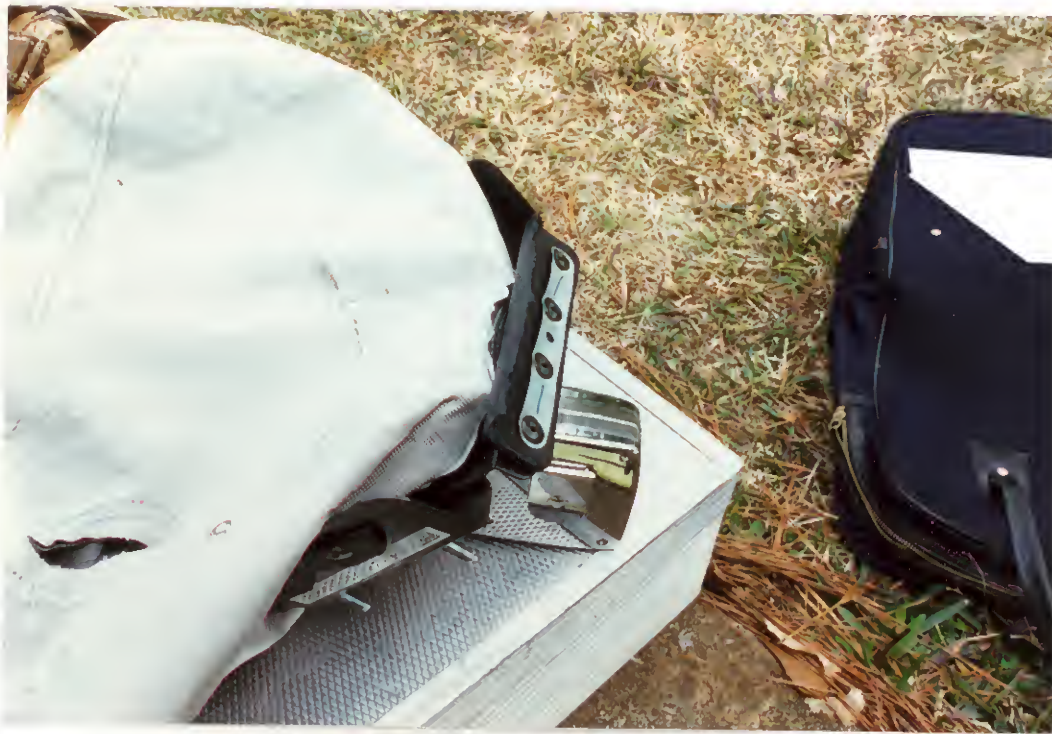
27. & 28. Separated upper module cover flap.

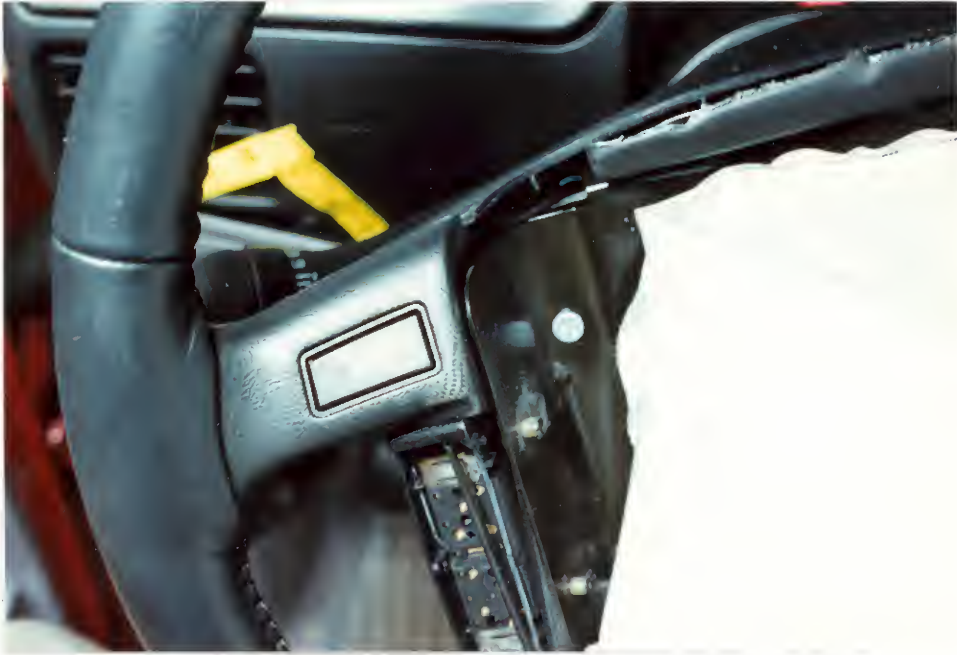
33. Air bag fabric transfer on the left upper steering wheel spoke.

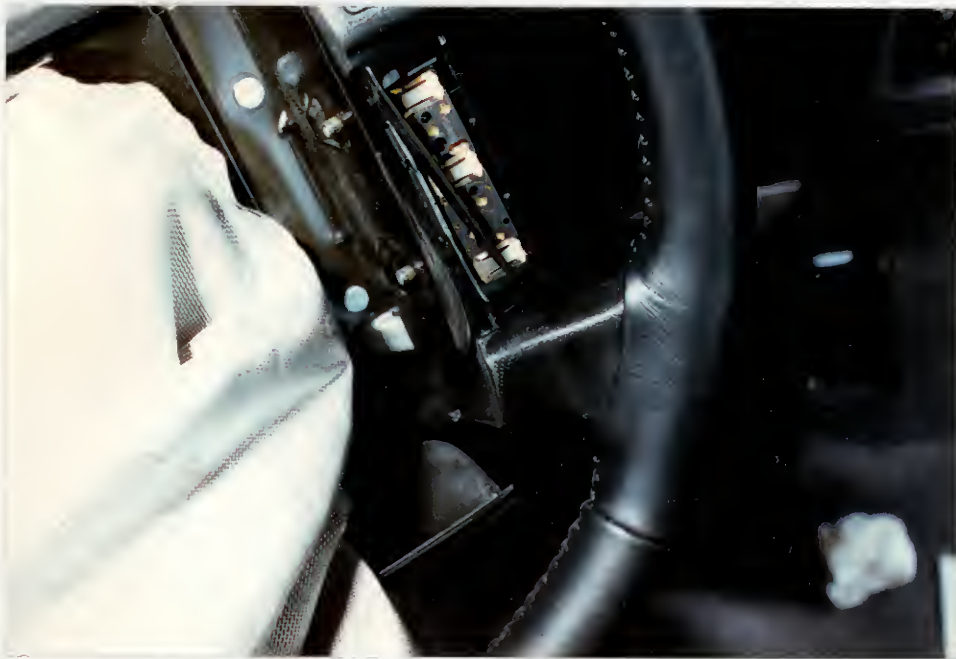
35. Damaged right cruise control switches and fabric transfers to the right lower spoke.

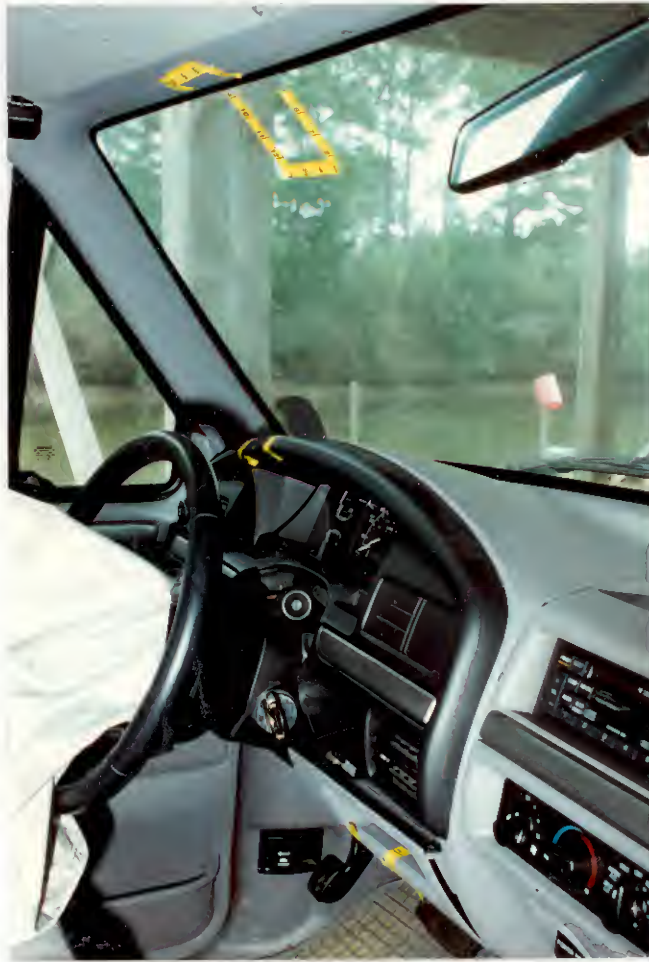
37. Driver's forehead contact to the windshield header and windshield.

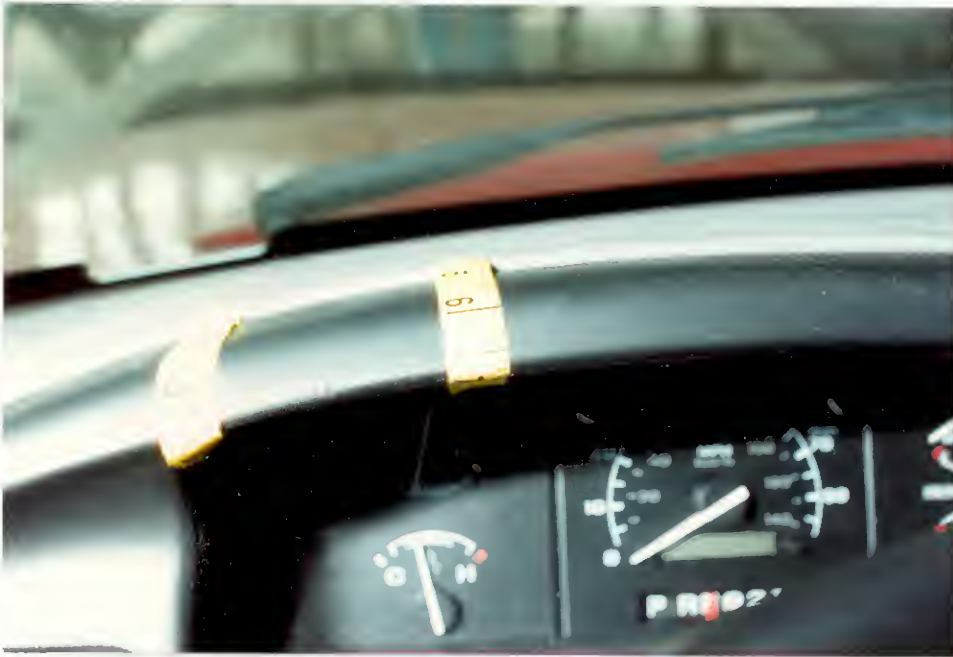
39. Probable contact from the separated upper module cover flap.

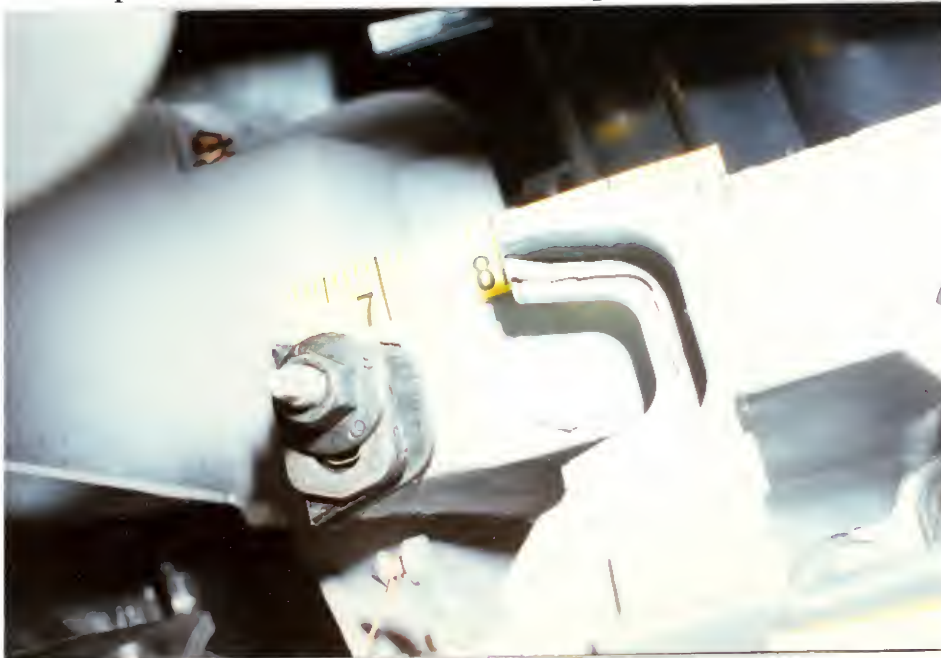
The driver's loading force against the steering assembly and the air bag module, in combination with the deploying air bag expanding against his chest, produced compression of the energy absorbing steering column. The deformable bracket of the energy absorbing column was displaced 4.4 cm (1.75") forward. Compression of the steering column resulted in complete separation of the shear capsules. The left side alloy bracket fractured and the right had separated 5.4 cm (2.1").

42. Compression of the right side steering column shear capsule.

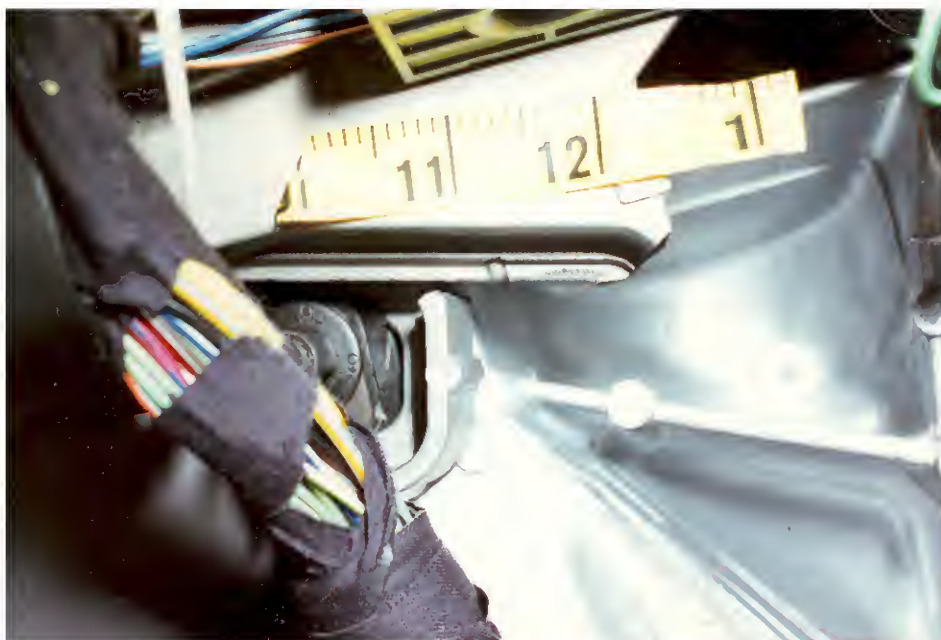
The driver's forward trajectory, in combination with the expansion of the air bag between the driver and the steering wheel, compressed the energy absorbing steering column approximately 5.70 cm (2.25"). The left alloy shear bracket was displaced 0.9 cm (0.4") forward and subsequently fractured as the column was driven forward. The separation between the fracture points was 4.8 cm (1.9"). The right shear bracket remained intact and had separated 5.3 cm (2.1") from the fixed shear block. At the base of the steering column was a deformable bracket which was displaced forward

43. Fractured left side shear capsule alloy bracket.

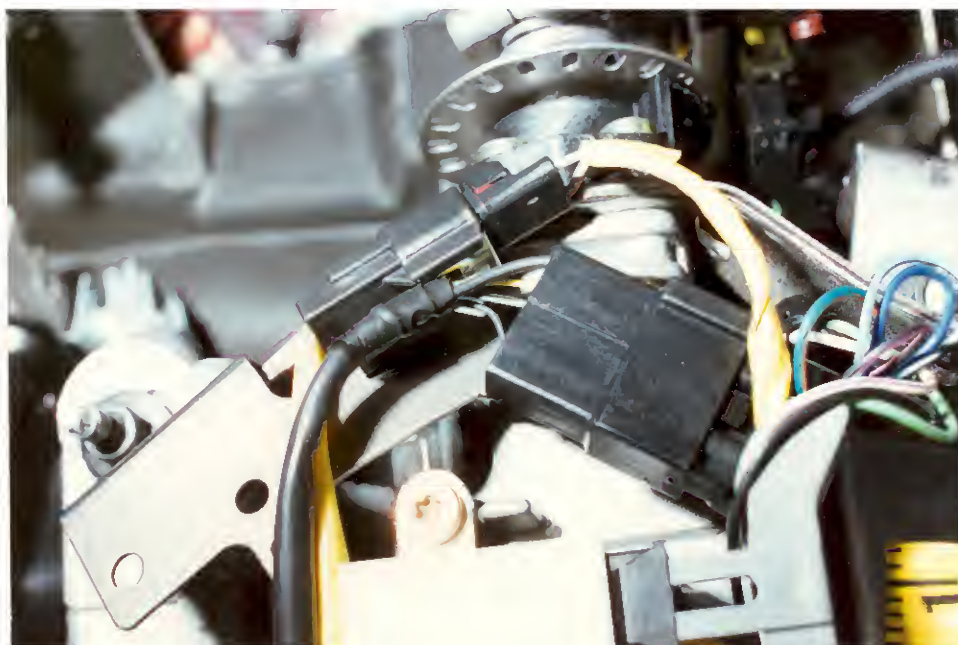
approximately 4.5 cm (1.75"). There was no damage or bending to the four spoke steering wheel which indicates that a uniform loading force was applied to the wheel. This is consistent with the loading pattern from the bag against the steering wheel spokes and the wide area of injury to the driver which extended from the umbilicus to the underside of the chin. The driver's knees contacted and scuffed the knee bolster on each side of the steering column. No injury resulted to the knees from the bolster contact.

44. Deformable bracket at the base of the energy absorbing steering column.

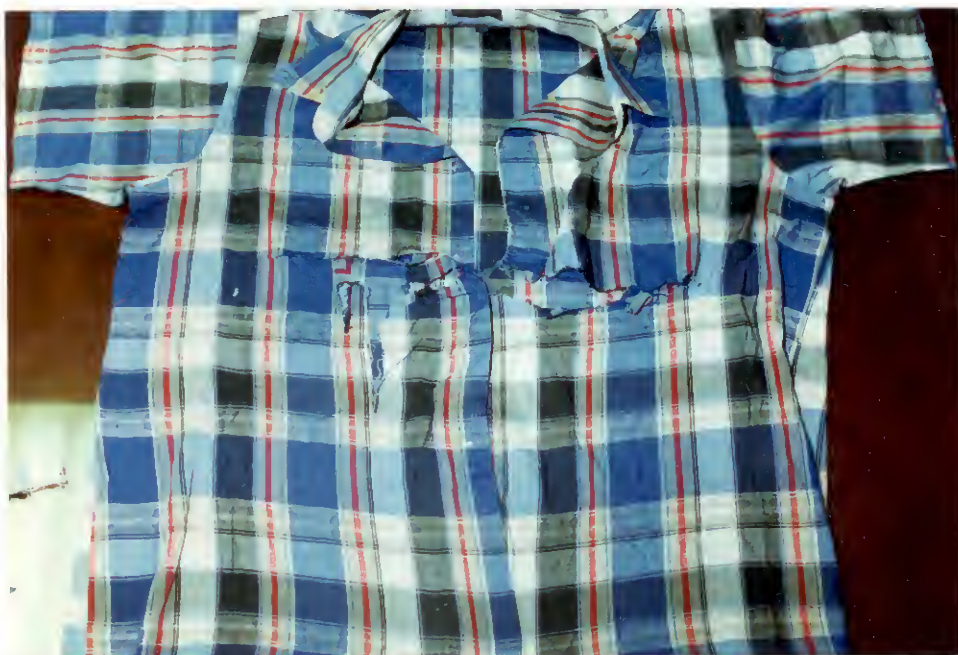
48. Horizontal tear across the chest area of the driver's shirt.

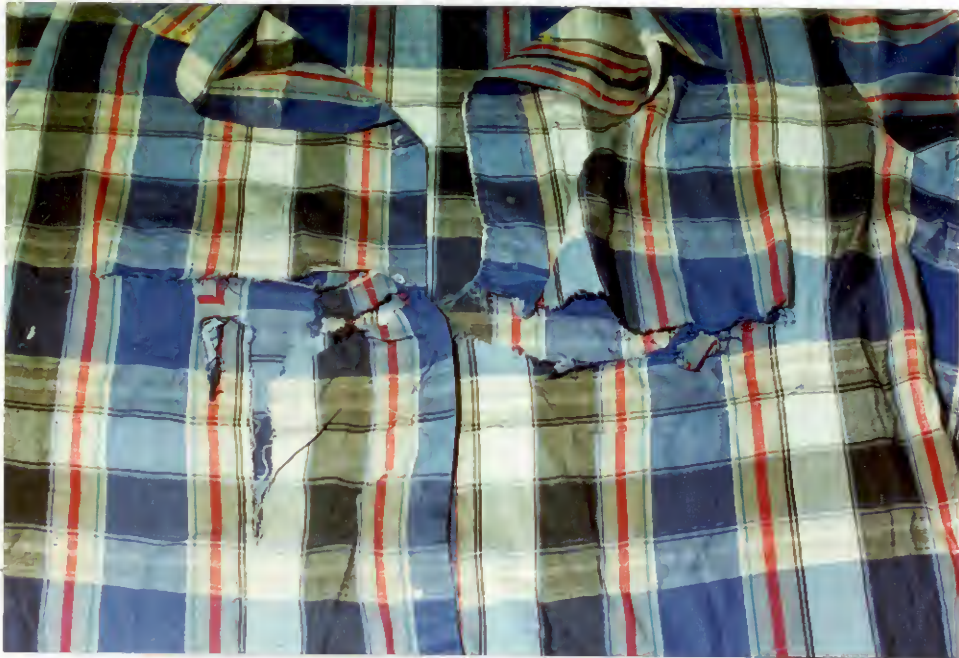
49. Close-up view of the tear pattern.

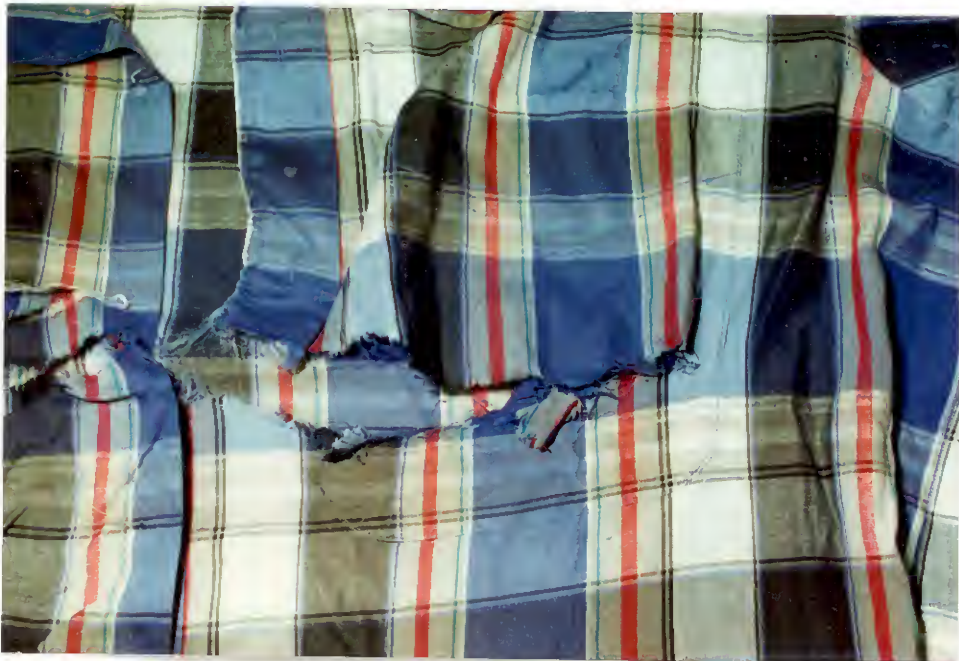
50. Tear across the left pocket.

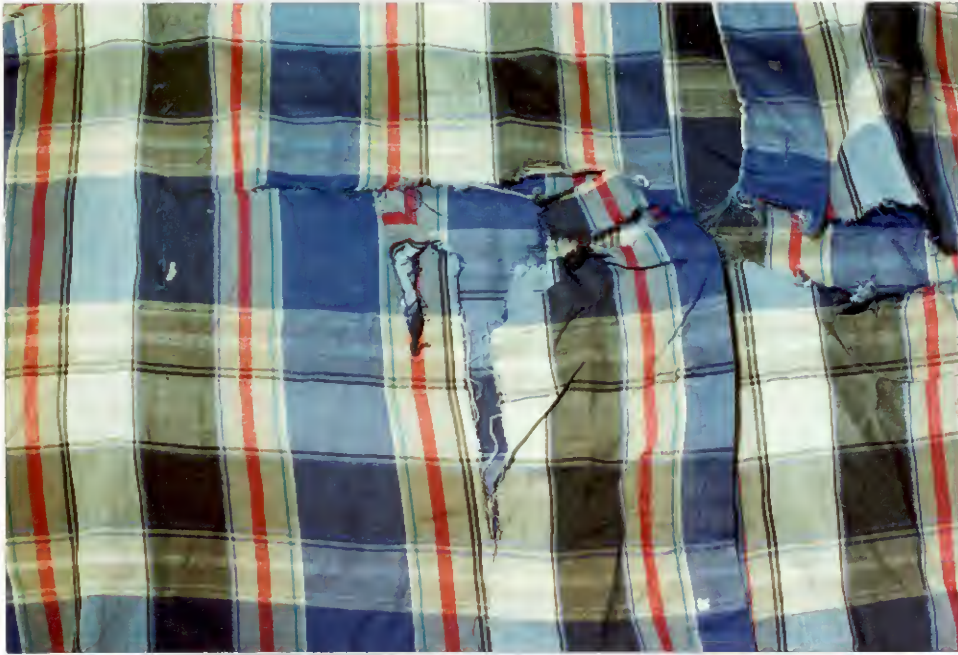
51. Tear across the right pocket area.
